VIBRODINAMIC MONITORING OF PILE FOUNDATION ENGINEERING ON LANDSLIDE HAZARDOUS SITE IN DENSE URBAN DEVELOPMENT CONDITIONS

Abstract. *An example of the application of modern regulatory requirements for the scientific and technical support of construction and monitoring of building structures for the safe arrangement of the pile foundation on a landslide hazardous building site in conditions of dense urban development in Kyiv during the installation of a Ø820 mm bored pile according to the plan of the pile field has been considered. Experimentally registered levels of vibration acceleration on the foundation wall of the building in the vertical and horizontal directions do not exceed 0.015 m/s², which is significantly lower than the minimum permissible values of vibration acceleration for the foundations of buildings with brick bearing walls 0,15 m/s². The research also evaluated the presence of visible damage to the building in the available places and their possible development before and after piles placement. The condition of the plaster screed on a vertical crack in the wall of the house on the 8th floor, which was installed before the start of construction work, after pile foun

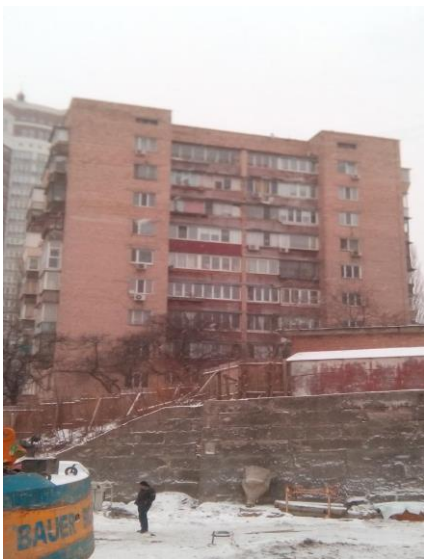
Fig. 1 – Investigated building and retaining wall view

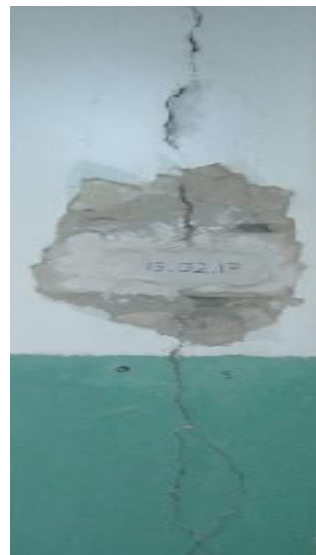
Fig. 2 – Chalky screed state after pile installation

According to the present DBN [6–11] the inspection of technical condition of the building structures of the nine-storey building was performed in advance, prior to conducting drilling works, (Fig. 1). During the study of the technical condition of building constructions, the presence of visible damage in the places available for this site and their possible development before the works beginning, during and after the installation of the piles were assessed. The monitoring of the impact on building of drilling operations was monitored not only instrumentally, but also visually, by periodic observations during the arrangement of the bored pile № 87 Ø820 mm taking into account the integrity of the chalky screed on a vertical crack in the bearing brick wall of the house on the 8th floor. The screed was installed in advance, prior to drilling operations beginning (see Fig. 2).

3. In the studies, the presence of visible damages to the building in the available places and possible development before and after pile installation was also assessed. Their development was evaluated according to a plaster screed on a vertical crack in the wall of the house. The condition of the chalky screed was established prior to the beginning of vibration dynamical tests on 02/15/2017 on the vertical crack in the building on the 8th floor, on the date of research on 02/21/2017 and after the installation of the concrete pile and further entire pile foundation has not changed. It remained undamaged. This is shown in the photo (Fig. 2).

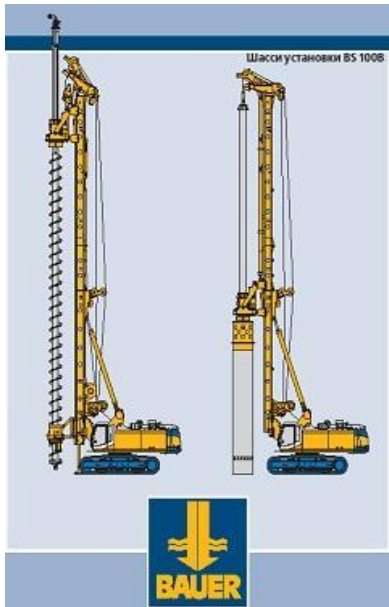
Well drilling was performed by the BAUER 40 BG drilling rig (Fig. 3). In the photo (Fig. 4) there is a view of the investigated building, including the retaining wall on the side of the construction site. During the research period, one drilling rig BAUER 40 BG (Fig. 3) worked on the site.

Fig. 3 – Rotary drilling rig BG 40

4. Based on the above mentioned, it is permissible to carry out work on pile foundation implementation with the observance of the necessary technological procedures during the operation of the BAUER 40 BG drilling rig (see Fig. 3–4).

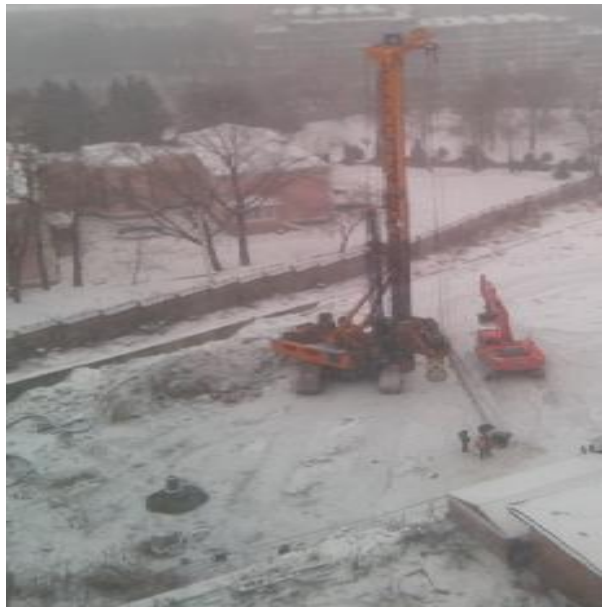
Fig. 4 – Construction site location near the building toe 14, Pimonenko street (view from the flat on the 9th floor)

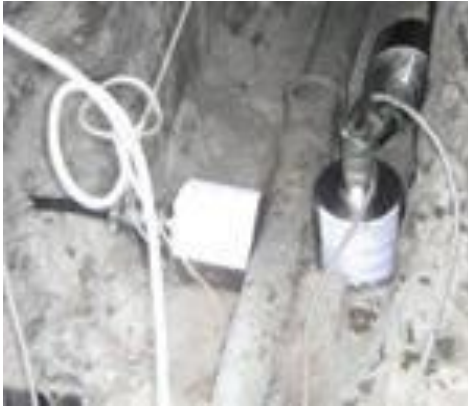
The vibration sensors were located on the foundation part of the building (3 vibration sensors), fixed oriented towards X, Z and Y directions (Fig. 5); two vibration sensors that were located on the floor of the 9th floor of the house were oriented towards X, Z or Y, Z directions (Fig. 6). The change in the orientation of the vibration sensors for the measurement of vibration acceleration was conducted in concert with the moment of their registration.

Fig. 5 – Vibration sensors № 1, № 2, № 3 for foundation oscillations registration towards X, Z and Y directions

1. The registered vibration acceleration levels on the foundation wall of the building in the vertical and horizontal directions do not exceed 0.015 m/s^2 , which is considerably less than the minimum permissible values of vibration acceleration for the foundations of buildings with brick bearing walls $0,15 \text{ m/s}^2$ according to Table 2 in [30].

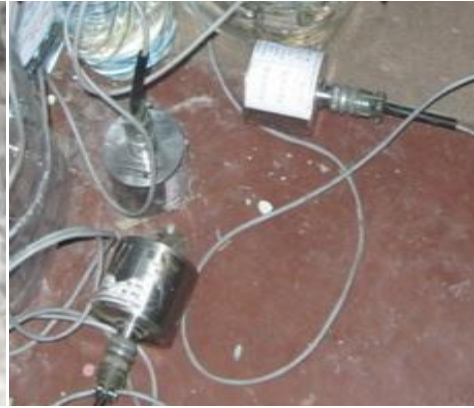
Fig. 6 – Vibration sensors № 4 and № 5 for registration of oscillations of the top 9th floor of the building towards X, Z or Y, Z directions

2. The registered levels of vibration acceleration at the level of the 9th floor slab of the building in the vertical and horizontal directions do not exceed 0.004 m/s^2 , which is significantly lower than the permissible values of vibration acceleration for high-rise buildings of 0.08 m/s^2 in according with paragraph 7.2 [31].
