## APPLYING MODERN CONSTRUCTION 4.0 TECHNOLOGY TO DAMAGED BUILDINGS

**Abstract.** *The work purpose was to conduct a comparative analysis investigating the damage caused to a high-rise building (HRB) under dynamic impacts of two types: periodic industrial explosions at the iron ore quarry of «UGOK» mining and processing plant in Kryvyi Rih and a rocket strike on HRB in Kyiv on February 26, 2022. fib bulletin 59 was used as the basis. The study demonstrates how the life cycle curve of HRB transforms under periodic dynamic impacts and a one-time combat action influence compared to the standard fib bulletin 59 curve. The applied methods included visual and instrumental inspection of buildings using non-destructive testing methods, geodetic and vibration instruments with IoT for refining initial-boundary conditions during the creation of the HRB Construction 4.0 (Digital Twins). Therefore, its experimental verification was conducted. The calculation package LIRA-CAD was used for calculations. It can be noticed while comparing vibration displacement projections at identical points of buildings 6-A and 6-B. Under current conditions, the operational lifespan of 6-A decreases by approxima

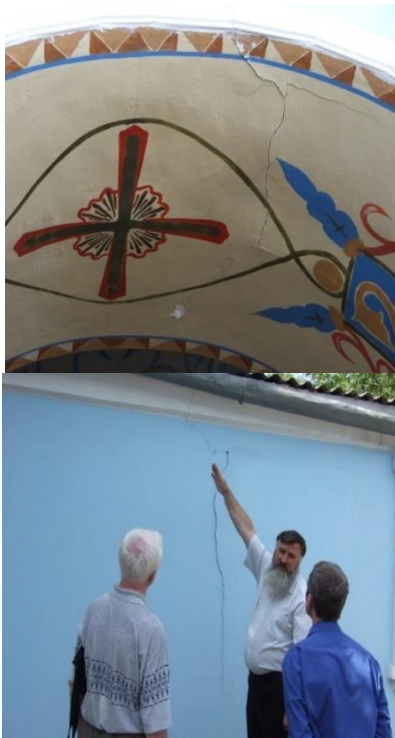
Fig. 2. Church's reaction to the explosion in the quarry. Top – cracks in the brick vault of the Church. Bottom – the priest pointing out vertical cracks on his house located within the Church's premises

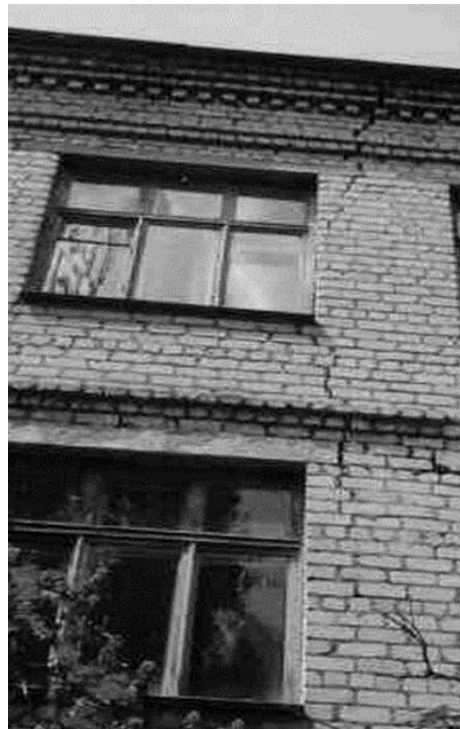
Fig. 3. Visual inspection of School No. 40 revealed cracks up to 0.05 m wide in external load-bearing walls. Crack gauges and vibration monitoring are required to assess seismic and explosion-related impacts

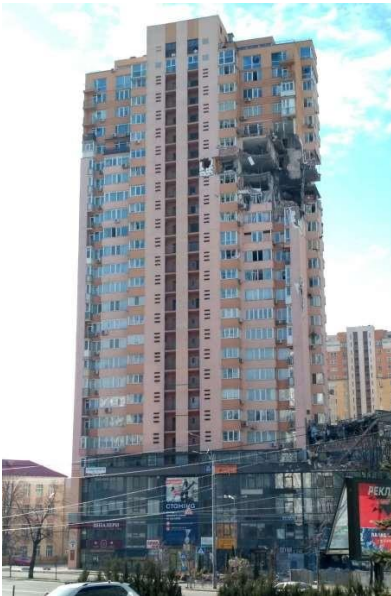
Fig. 6. General view of the building at 6A Lobanovsky Avenue after the rocket impact on April 26, 2022

The investigation was conducted on the high-rise building at 6-A Lobanovskyi Avenue in Kyiv, which suffered significant damage from a missile strike on February 26, 2022 (Figure 6, Figure 7).

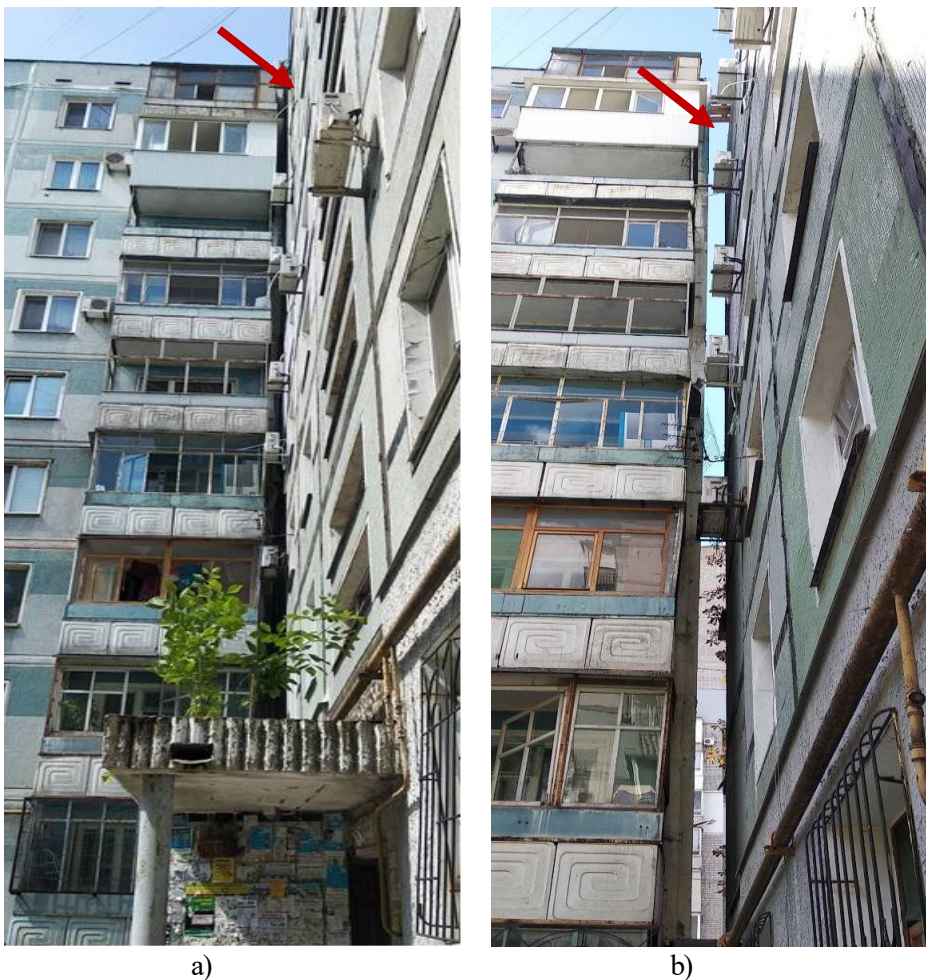
Fig. 9. General view of the deformation seam between block sections No. 3 and No. 1 before straightening (a); and after straightening (b) at 23, 25, Engineer Preobrazhenskyi St., Zaporizhzhya, Ukraine [10]

The structural scheme of the building is frameless, with plan dimensions of 24x12 meters. The spatial rigidity is ensured by load-bearing longitudinal and transverse walls made of expanded clay concrete with a thickness of 0.35...0.45 meters, as well as reinforced concrete floors. During operation, the building was subjected to subsidence deformations. The longitudinal and transverse tilts reached excessive values. As a result of calculating the Model of the building for the impacts and loads that occurred during operation, its 3D SSS was obtained from the combined effect of external loads and subsidence deformations, along with node displacements of the Model for each of the calculation options [10, 11]. The principal stresses in the building elements were calculated and analyzed, providing an assessment of the strength of the materials in its structural elements. Since the building did not meet the conditions for normal operation due to excessive tilts caused by subsidence deformations, it was decided to eliminate these tilts. The building's tilt was corrected by drilling the calculated amount of soil from under the foundation's footing. For this, a trench was dug along the building facade to a depth of one meter below the foundation. The weakening of the base layer (compacted loess loam) was achieved by drilling two rows of horizontal cylindrical boreholes up to 15 meters long with variable diameters of 0.16...0.22 m. Moistening the borehole walls accelerated the process of technological settlements to the required value. The work to form the building's counter-tilt lasted 14 days. Uneven settlements of the building in the longitudinal direction were achieved at 0.041...0.055 m, and in the transverse direction – at 0.092...0.178 m (see Fig. 9).
